**Flood Control Project Maintenance  
Levee Inspections**

## Maintenance Issue Types Only, Levee Inspection Report By Mile - Spring 2018

### Reclamation District No. 1600 Mull

Waterway	Bank	Unit Miles	Inspection Start/End	Inspector
Unit No. 01 Sacramento River	Right	10.46	04/10/2018 05/08/2018	Zach Jojola

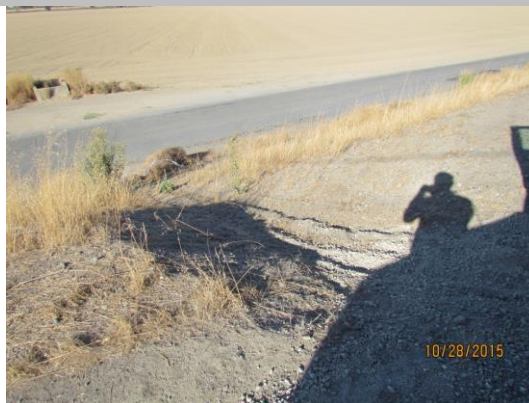
Photo 2 of 2 : SP\_2018\_RD1600\_191\_133\_20180306\_00062.jpg

LM Start	0.53	Rating **	M	Issue No.	133 (cont)	
LM End	0.53	Issue Type +	Ma	Location *	LS	
Category	Earthen Levee			GPS Latitude/Longitude		
				Start	End	
Item	Slope Stability			38.682140 °	38.682140 °	
				-121.634083 °	-121.634083 °	
DWR ID	DWR_RD1600_01_f_2013_133					
Comment Code						
S2 : Repair the levee slope damaged by foot traffic and prevent access where possible.						
Inspector Comment						
Footpath on landside slope over pipe crossing.

View of the slope stability on the landward side of the levee. Fall 2015.

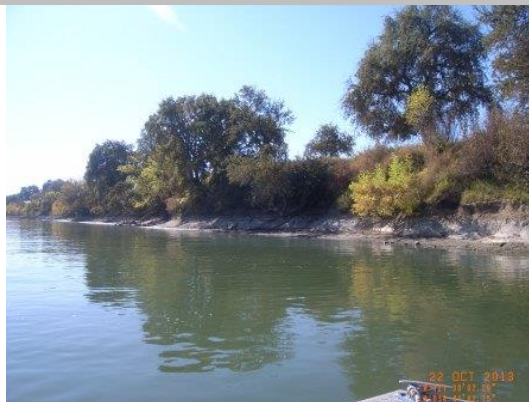
Photo 1 of 1 : SP\_2018\_RD1600\_191\_7\_20180306\_00009.jpg

LM Start	0.56	Rating **	A/W	Issue No.	7
LM End	0.66	Issue Type +	Ma	Location *	WS
Category	Supplemental			GPS Latitude/Longitude	
				Start	End
Item	2015 USACE Erosion Survey, DRAFT			38.682707 °	38.684106 °
				-121.633830 °	-121.634219 °
DWR ID	DWR_RD1600_01_s_2016_7				
Comment Code					
Inspector Comment					
2000 - Very cohesive vertical bank. 2003 - Some minor new erosion. 2006 - Some minor erosion in old pockets. 2009 - Minimal new erosion. 2011 - Multiple new erosion pockets and a few new tree popouts. 2015: No observed changes. [2015 Site ID: SAC_71-3_R]

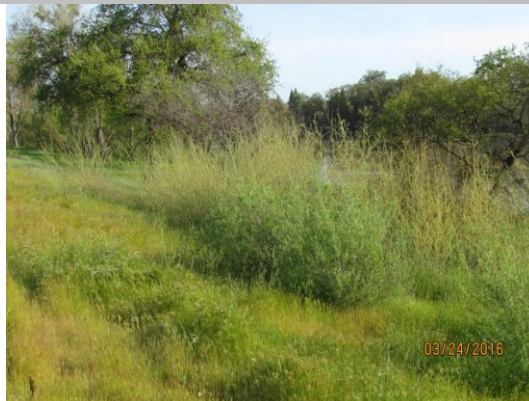
Photo 1 of 3 : SP\_2018\_RD1600\_191\_29\_20180306\_00029.jpg

LM Start	0.60	Rating **	M	Issue No.	29
LM End	0.62	Issue Type +	Ma	Location *	WS
Category	Earthen Levee			GPS Latitude/Longitude	
				Start	End
Item	Vegetation			38.683238 °	38.683415 °
				-121.634388 °	-121.634448 °
DWR ID	DWR_RD1600_01_s_2016_29				
Comment Code					
V2 : Remove the wild growth other than native grasses from the levee slopes.					
Inspector Comment					
Recommend removal of willow trees.

Perspective view of the willows on the waterward side of the levee looking upstream. Spring 2016.

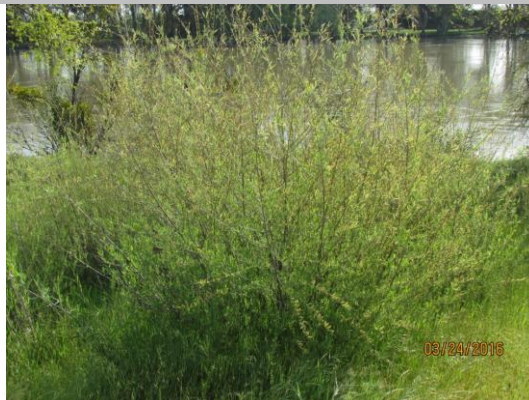
Photo 2 of 3 : SP\_2018\_RD1600\_191\_29\_20180306\_00030.jpg

Willows are growing on the waterward side of the levee. Spring 2016.

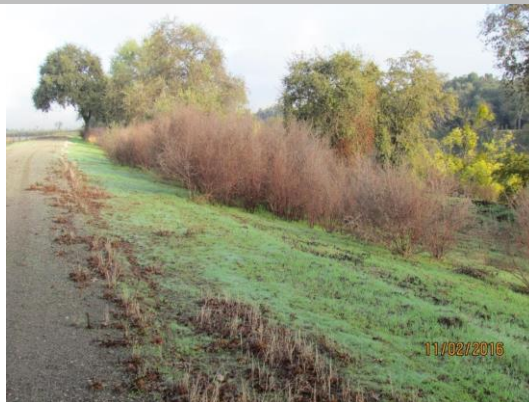
Photo 3 of 3 : SP\_2018\_RD1600\_191\_29\_20180306\_00031.jpg

Updated view of willows on waterward side. Fall 2016.

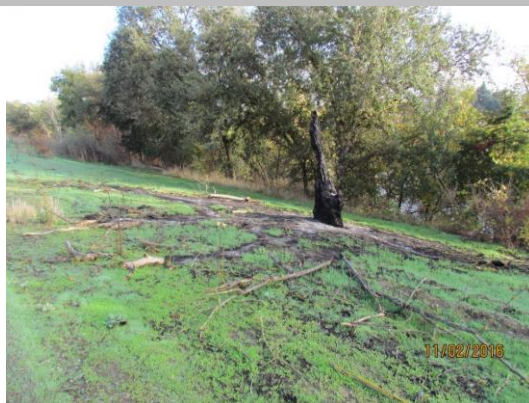
Photo 1 of 1 : SP\_2018\_RD1600\_191\_624\_20180306\_00068.jpg

LM Start	0.78	Rating **	N	Issue No.	624
LM End	0.78	Issue Type +	Ma	Location *	WS
Category	Earthen Levee			GPS Latitude/Longitude	
				Start	End
Item	Trim / Thin Trees			38.685713 °	38.685713 °
				-121.634985 °	-121.634985 °
DWR ID	DWR_RD1600_01_s_2017_624				
Comment Code					
T5 : Tree stumps.					
Inspector Comment					
Burnt stump on waterside slope.

View of burnt tree on waterside slope. Fall 2016.

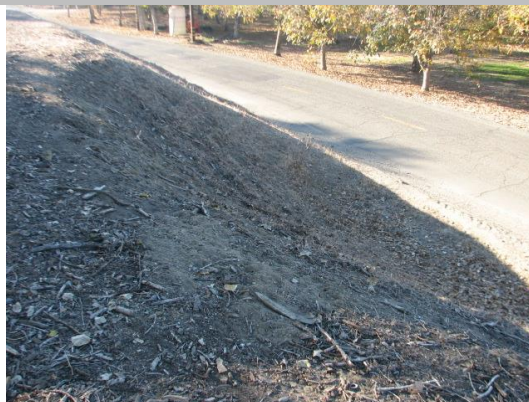
Photo 1 of 2 : SP\_2018\_RD1600\_191\_134\_20180306\_00063.jpg

LM Start	0.97	Rating **	M	Issue No.	134
LM End	0.97	Issue Type +	Ma	Location *	LS
Category	Earthen Levee			GPS Latitude/Longitude	
				Start	End
Item	Slope Stability			38.688454 °	38.688454 °
				-121.635528 °	-121.635528 °
DWR ID	DWR_RD1600_01_f_2013_134				
Comment Code					
S1 : Repair slope instability.					
Inspector Comment

The levee has a deep depression caused by removed tree. Fall 2013

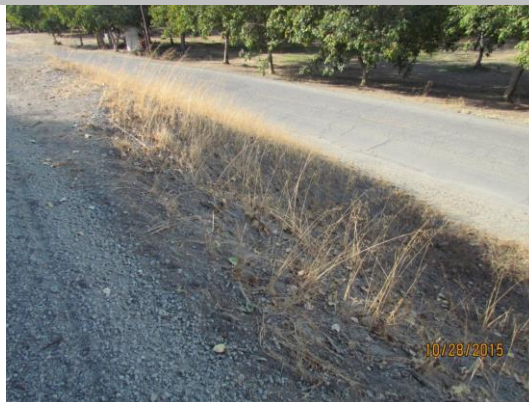
Photo 2 of 2 : SP\_2018\_RD1600\_191\_134\_20180306\_00064.jpg

View of the depression of the slope on the landward side of the levee looking downstream. Fall 2015.

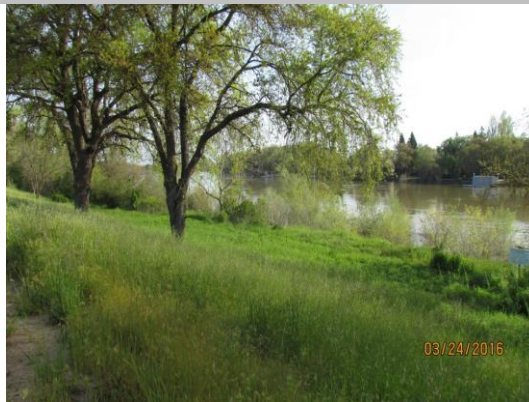
Photo 1 of 2 : SP\_2018\_RD1600\_191\_22\_20180306\_00021.jpg

View of the revegetation site at the berm edge on the waterward side of the levee looking upstream. Spring 2016.

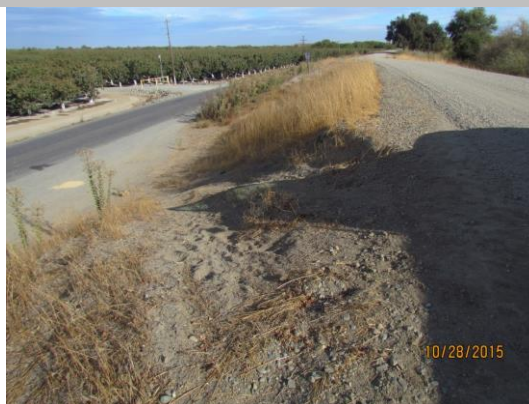
Photo 1 of 1 : SP\_2018\_RD1600\_191\_4\_20180306\_00005.jpg

LM Start	1.40	Rating **	A/W	Issue No.	4
LM End	1.40	Issue Type +	Ma	Location *	LS
Category	Earthen Levee			GPS Latitude/Longitude	
				Start	End
Item	Slope Stability			38.694452 °	38.694452 °
				-121.634292 °	-121.634292 °
DWR ID	DWR_RD1600_01_s_2017_4				
Comment Code					
S3 : Repair the levee slope damaged by vehicle traffic and prevent access where possible.					
Inspector Comment					
Vehicle access point. Recommend monitoring.

View of the slope stability caused by vehicles on the landward side of the levee looking upstream. Fall 2015.

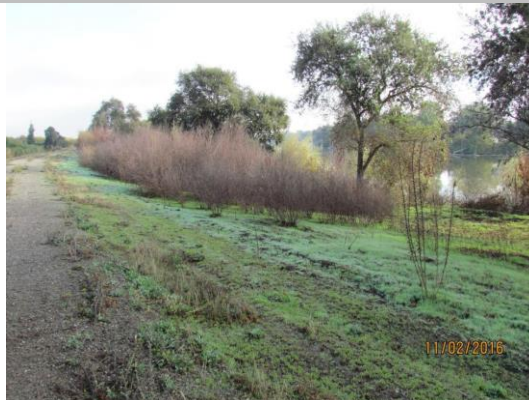
Photo 1 of 1 : SP\_2018\_RD1600\_191\_50\_20180306\_00043.jpg

LM Start	1.53	Rating **	M	Issue No.	50
LM End	1.58	Issue Type +	Ma	Location *	WS
Category	Earthen Levee			GPS Latitude/Longitude	
				Start	End
Item	Vegetation			38.696341 °	38.696918 °
				-121.633417 °	-121.633044 °
DWR ID	DWR_RD1600_01_s_2016_50				
Comment Code					
V2 : Remove the wild growth other than native grasses from the levee slopes.					
Inspector Comment					
Recommend removal of willows on waterward side of the levee.

View of willows on waterward side of the levee. Recommended removal. Fall 2016.

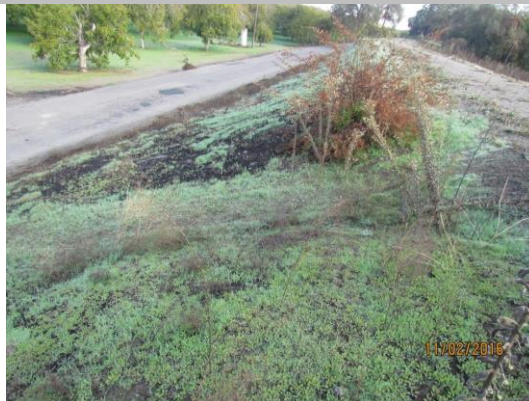
Photo 1 of 1 : SP\_2018\_RD1600\_191\_70\_20180306\_00051.jpg

LM Start	1.70	Rating **	A/W	Issue No.	70
LM End	1.70	Issue Type +	Ma	Location *	LS
Category	Earthen Levee			GPS Latitude/Longitude	
				Start	End
Item	Slope Stability			38.698414 °	38.698414 °
				-121.631874 °	-121.631874 °
DWR ID	DWR_RD1600_01_f_2017_70				
Comment Code					
S2 : Repair the levee slope damaged by foot traffic and prevent access where possible.					
Inspector Comment					
Footpath on landside slope.

View of slope instability. Fall 2016.

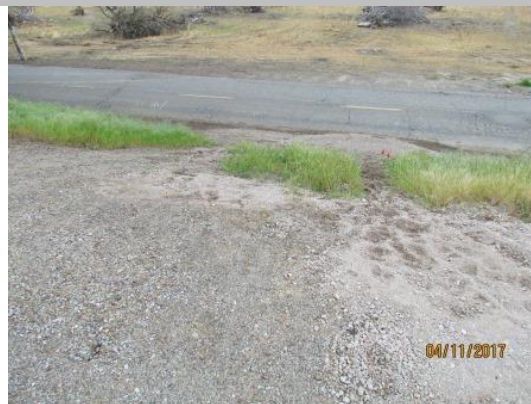
Photo 1 of 4 : SP\_2018\_RD1600\_191\_72\_20180306\_00055.jpg

LM Start	2.01	Rating **	M	Issue No.	72
LM End	2.01	Issue Type +	Ma	Location *	LS
Category	Earthen Levee			GPS Latitude/Longitude	
				Start	End
Item	Erosion / Bank Caving			38.701605 °	38.701605 °
				-121.627954 °	-121.627954 °
DWR ID	DWR_RD1600_01_s_2018_72				
Comment Code					
E2 : Schedule repair of erosion site prior to the next inspection.					
Inspector Comment					
Rills on landside slope.

Updated view of the erosion site. Spring 2017.

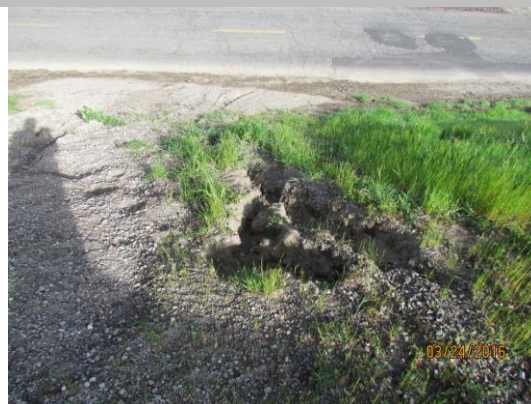
Photo 2 of 4 : SP\_2018\_RD1600\_191\_72\_20180306\_00052.jpg

Erosion is on the landward side of the levee about midway from the shoulder of the levee. Spring 2016.

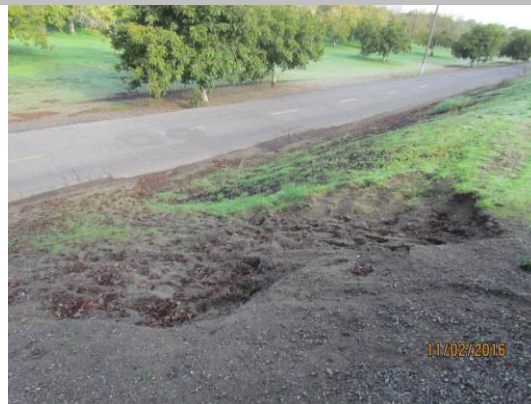
Photo 3 of 4 : SP\_2018\_RD1600\_191\_72\_20180306\_00053.jpg

Updated view of the erosion site. Fall 2016.

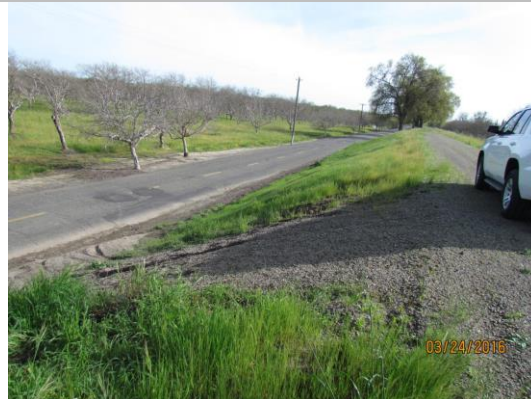
Photo 4 of 4 : SP\_2018\_RD1600\_191\_72\_20180306\_00054.jpg

LM Start	2.01	Rating **	M	Issue No.	72 (cont)
LM End	2.01	Issue Type +	Ma	Location *	LS
Category	Earthen Levee			GPS Latitude/Longitude	
				Start	End
Item	Erosion / Bank Caving			38.701605 °	38.701605 °
				-121.627954 °	-121.627954 °
DWR ID	DWR_RD1600_01_s_2018_72				
Comment Code					
E2 : Schedule repair of erosion site prior to the next inspection.					
Inspector Comment					
Rills on landside slope.

Perspective view of the erosion on the landward side of the levee looking upstream. Spring 2016.

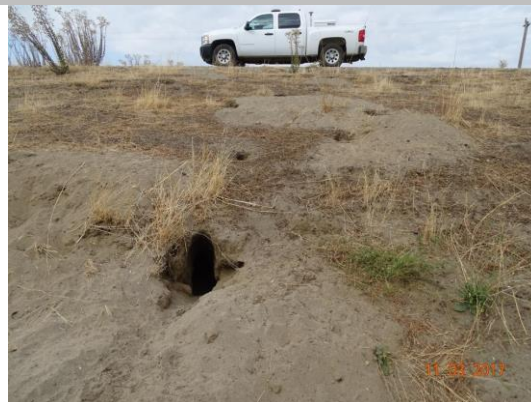
Photo 1 of 1 : SP\_2018\_RD1600\_191\_62\_20180306\_00048.jpg

View of rodent holes on waterside slope. Fall 2017.

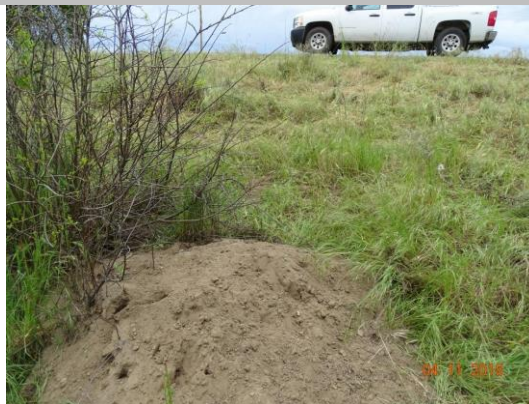
Photo 1 of 1 : SP\_2018\_RD1600\_191\_67\_20180413\_00099.jpg

View of rodent hole and mound on the waterside slope. Spring 2018.

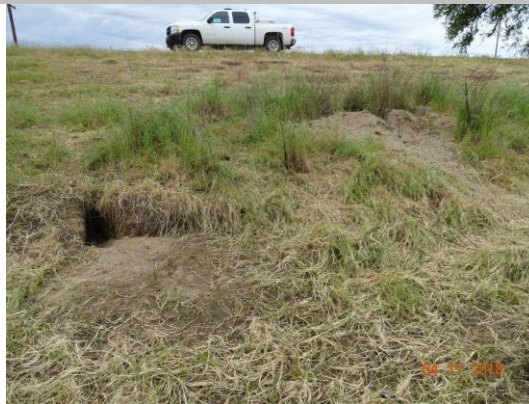
Photo 1 of 1 : SP\_2018\_RD1600\_191\_58\_20180413\_00098.jpg

View of rodents holes on the waterside slope. Spring 2018.

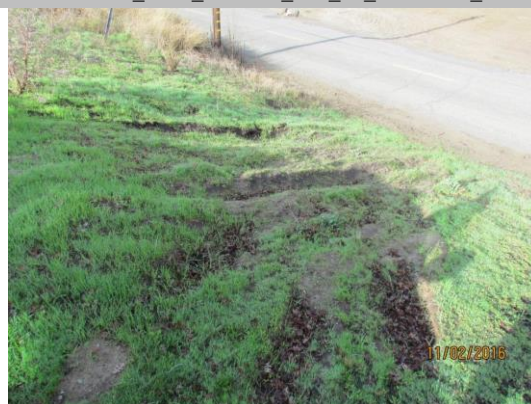
Photo 1 of 1 : SP\_2018\_RD1600\_191\_43\_20180306\_00038.jpg

LM Start	2.41	Rating **	M	Issue No.	43
LM End	2.41	Issue Type +	Ma	Location *	LS
Category	Earthen Levee			GPS Latitude/Longitude	
				Start	End
Item	Slope Stability			38.705203 °	38.705203 °
				-121.622184 °	-121.622184 °
DWR ID	DWR_RD1600_01_f_2016_43				
Comment Code					
S1 : Repair slope instability.					
Inspector Comment

View of slope instability on the landside slope. Fall 2016.

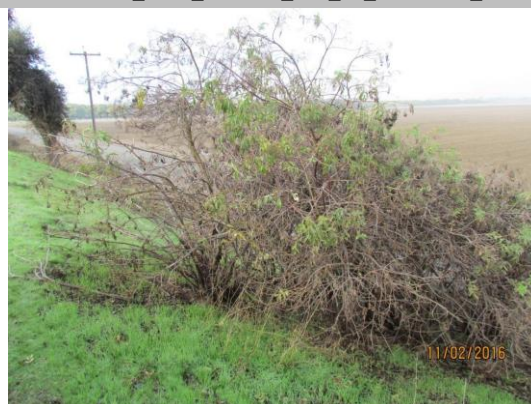
Photo 1 of 1 : SP\_2018\_RD1600\_191\_45\_20180306\_00039.jpg

Elderberry tree on landside slope. Fall 2016.

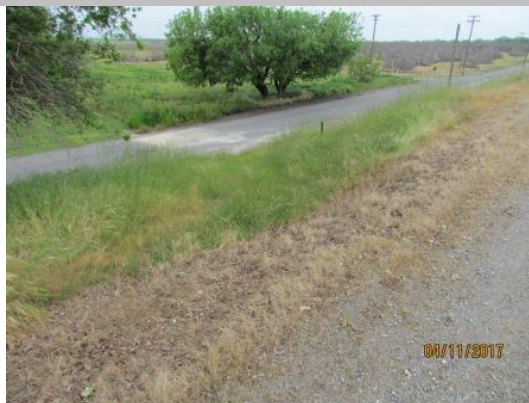
Photo 1 of 1 : SP\_2018\_RD1600\_191\_76\_20180306\_00057.jpg

LM Start	3.04	Rating **	M	Issue No.	76
LM End	3.04	Issue Type +	Ma	Location *	LS
Category	Earthen Levee			GPS Latitude/Longitude	
				Start	End
Item	Slope Stability			38.711660 °	38.711660 °
				-121.613839 °	-121.613839 °
DWR ID	DWR_RD1600_01_s_2017_76				
Comment Code					
S3 : Repair the levee slope damaged by vehicle traffic and prevent access where possible.					
Inspector Comment					
Slope depression on landside levee slope from vehicle traffic.

Slope depression on landside levee slope from vehicle traffic. Spring 2017.

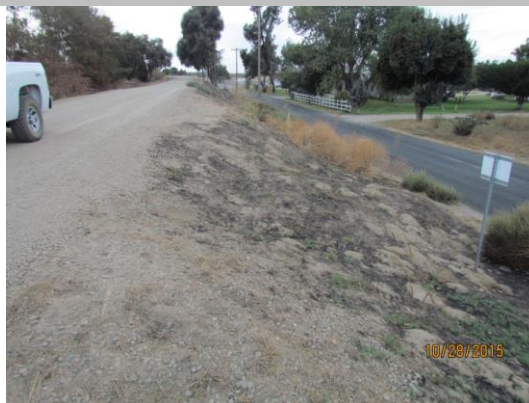
Photo 1 of 1 : SP\_2018\_RD1600\_191\_41\_20180306\_00037.jpg

LM Start	4.66	Rating **	A/W	Issue No.	41
LM End	4.66	Issue Type +	Ma	Location *	LS
Category	Earthen Levee			GPS Latitude/Longitude	
				Start	End
Item	Slope Stability			38.733294 °	38.733294 °
				-121.605484 °	-121.605484 °
DWR ID	DWR_RD1600_01_f_2015_41				
Comment Code					
S1 : Repair slope instability.					
Inspector Comment

View of the bulge at the toe of the levee on the landward side looking downstream. Fall 2015.

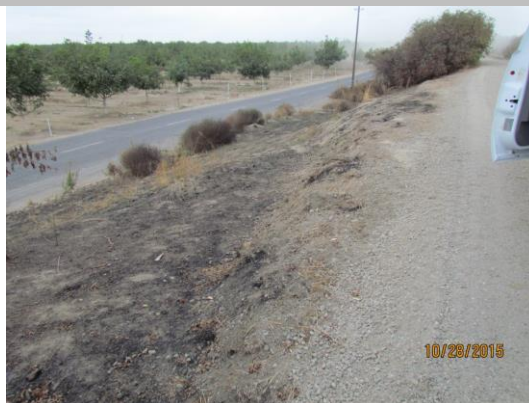
Photo 1 of 1 : SP\_2018\_RD1600\_191\_141\_20180306\_00066.jpg

LM Start	4.77	Rating **	M	Issue No.	141
LM End	4.77	Issue Type +	Ma	Location *	LS
Category	Earthen Levee			GPS Latitude/Longitude	
				Start	End
Item	Slope Stability			38.734840 °	38.734840 °
				-121.605026 °	-121.605026 °
DWR ID	DWR_RD1600_01_f_2013_141				
Comment Code					
S1 : Repair slope instability.					
Inspector Comment

View of the erosion on the landward side of the levee looking upstream.  
Fall 2015.

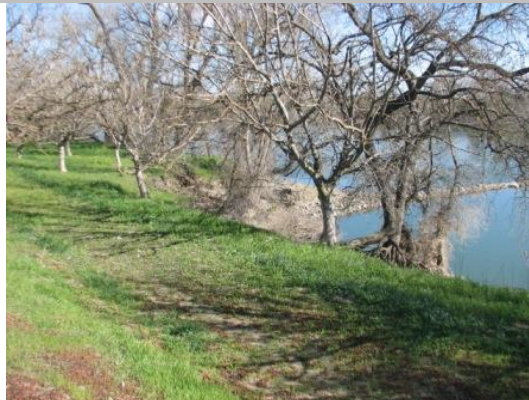
Photo 1 of 2 : SP\_2018\_RD1600\_191\_30\_20180306\_00032.jpg

Erosion is into the berm area and needs to be monitored. Spring 2013

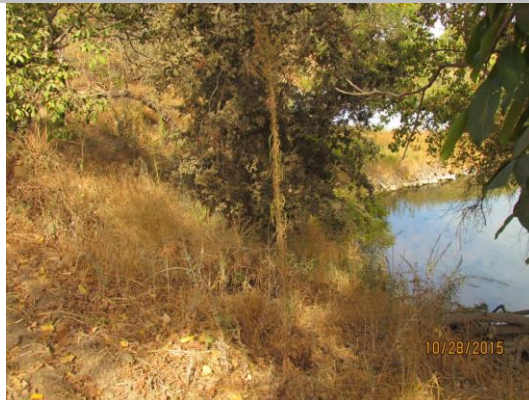
Photo 2 of 2 : SP\_2018\_RD1600\_191\_30\_20180306\_00033.jpg

View of the erosion into the berm area that needs to be monitored. Fall 2015.

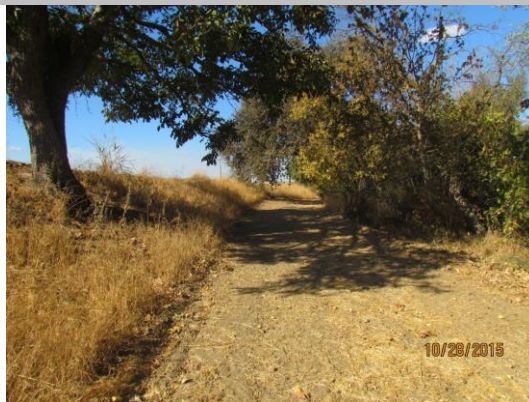
Photo 2 of 5 : SP\_2018\_RD1600\_191\_20\_20180306\_00014.jpg

View of the erosion in the berm area on the waterward side looking upstream. Fall 2015.

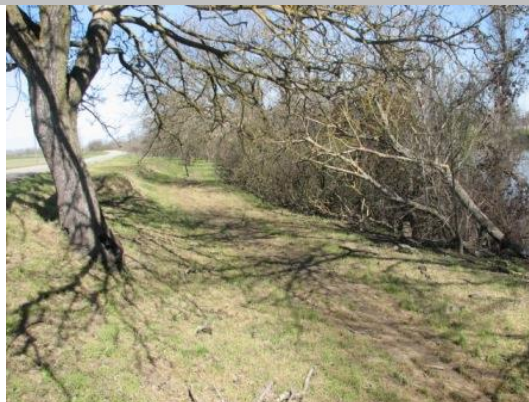
Photo 3 of 5 : SP\_2018\_RD1600\_191\_20\_20180306\_00015.jpg

The erosion is eroding away at the berm area.

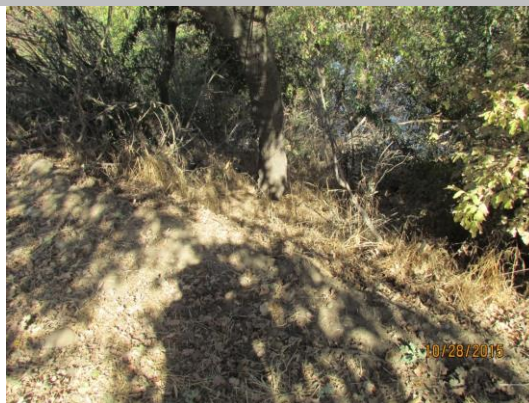
Photo 4 of 5 : SP\_2018\_RD1600\_191\_20\_20180306\_00016.jpg

Looking at the erosion site on the berm. Fall 2015.

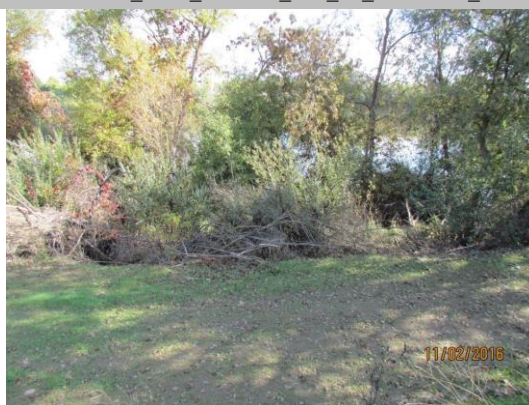
Photo 5 of 5 : SP\_2018\_RD1600\_191\_20\_20180306\_00017.jpg

Updated view of erosion site. Fall 2016.

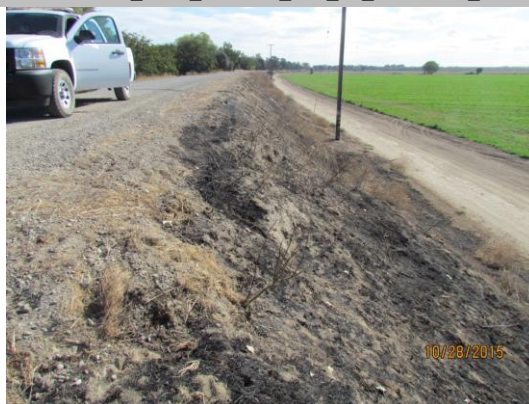
Photo 1 of 1 : SP\_2018\_RD1600\_191\_61\_20180306\_00047.jpg

View of the erosion on the landward side of the levee looking downstream. Fall 2015.

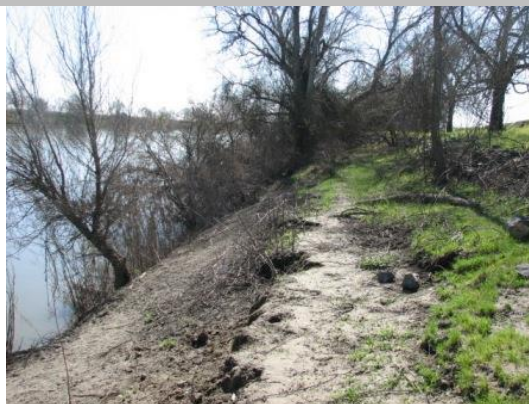
Photo 1 of 3 : SP\_2018\_RD1600\_191\_21\_20180306\_00018.jpg

The erosion is eroding away the berm area.

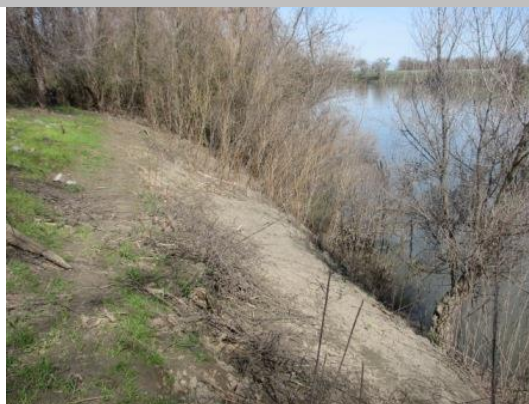
Photo 2 of 3 : SP\_2018\_RD1600\_191\_21\_20180306\_00019.jpg

The bank is eroding away and has become very steep.

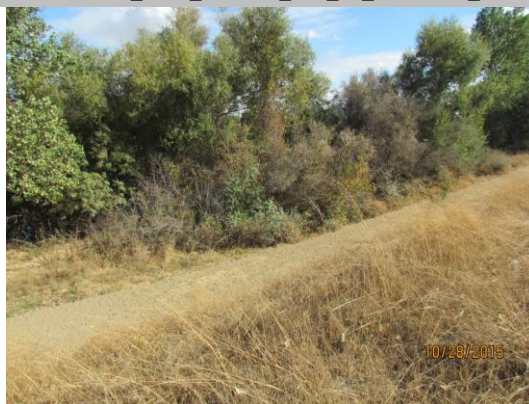
Photo 3 of 3 : SP\_2018\_RD1600\_191\_21\_20180306\_00020.jpg

View of the erosion along the waterward berm of the levee. Fall 2015.

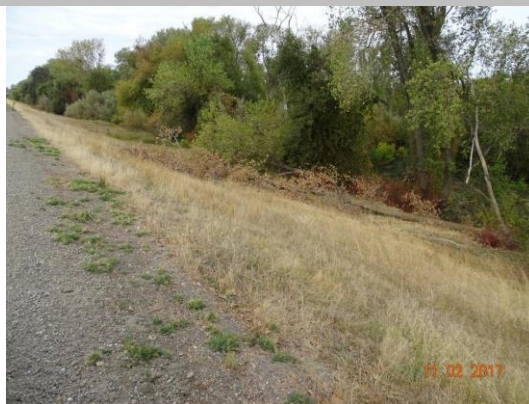
Photo 1 of 1 : SP\_2018\_RD1600\_191\_36\_20180306\_00036.jpg

View of fallen tree on waterside slope. Fall 2017.

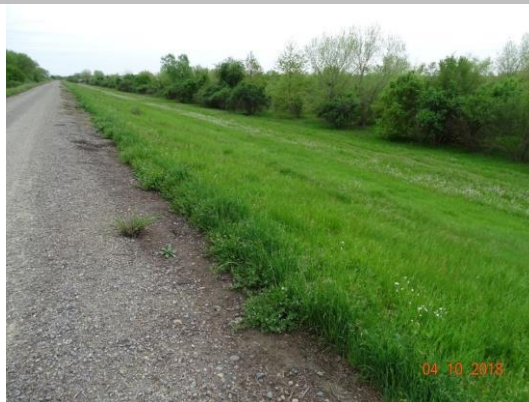
Photo 1 of 1 : SP\_2018\_RD1600\_191\_38\_20180413\_00097.jpg

View of vegetation on the landside slope. Spring 2018.

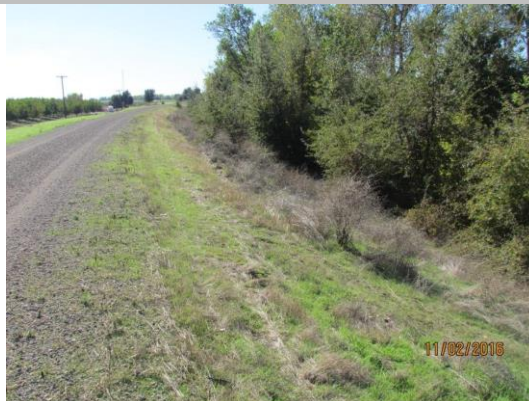
Photo 1 of 1 : SP\_2018\_RD1600\_191\_66\_20180306\_00050.jpg

Vegetation on WS slope has been cleared only about 10 ft. from the crown. Fall 2016.

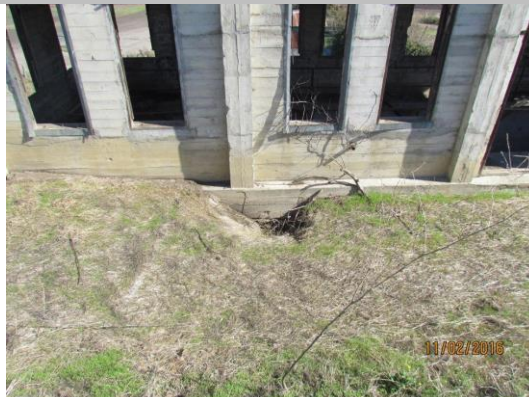
Photo 1 of 1 : SP\_2018\_RD1600\_192\_4\_20180306\_00001.jpg

LM Start	0.37	Rating **	M	Issue No.	4
LM End	0.37	Issue Type +	Ma	Location *	LS
Category	Earthen Levee			GPS Latitude/Longitude	
				Start	End
Item	Erosion / Bank Caving			38.730872 °	38.730872 °
				-121.633504 °	-121.633504 °
DWR ID	DWR_RD1600_02_f_2016_4				
Comment Code					
E2 : Schedule repair of erosion site prior to the next inspection.					
Inspector Comment

Landside levee slope erosion at RD1600 pumping plant. Fall 2016.

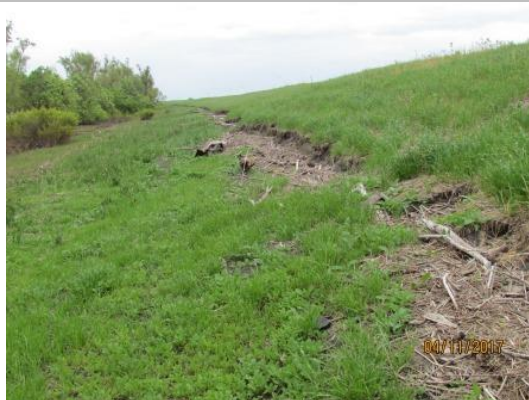
Photo 1 of 1 : SP\_2018\_RD1600\_192\_23\_20180306\_00019.jpg

View of wave wash damage on waterside levee slope. Spring 2017.

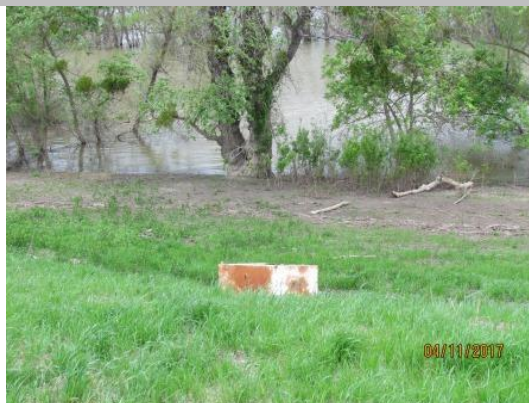
Photo 1 of 1 : SP\_2018\_RD1600\_192\_22\_20180306\_00018.jpg

Refrigerator on waterside levee slope. Spring 2017.

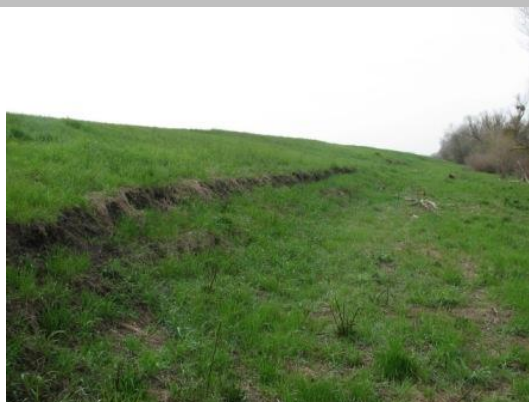
Photo 1 of 4 : SP\_2018\_RD1600\_192\_14\_20180306\_00007.jpg

A closer view of the wave wash damage along the bypass.

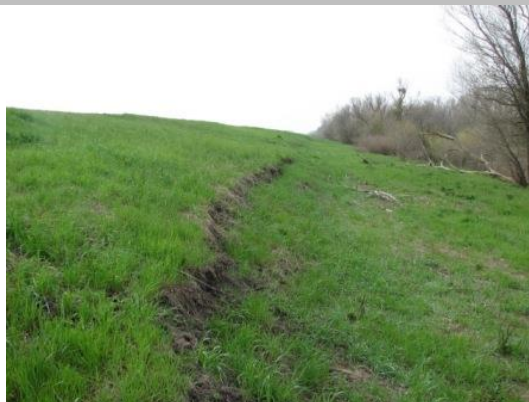
Photo 2 of 4 : SP\_2018\_RD1600\_192\_14\_20180306\_00008.jpg

Wave wash damage along the slope the cut is 1'-2'.

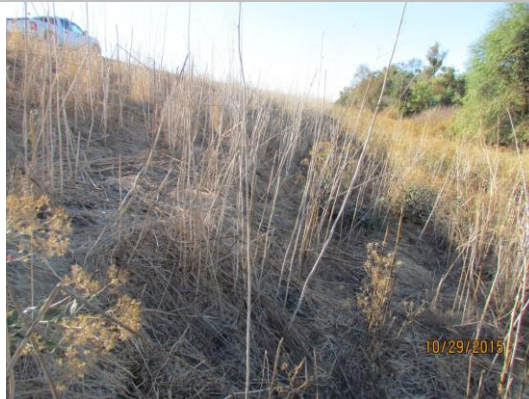
Photo 3 of 4 : SP\_2018\_RD1600\_192\_14\_20180306\_00009.jpg

View of the erosion on the waterward side of the levee looking downstream. Fall 2015.

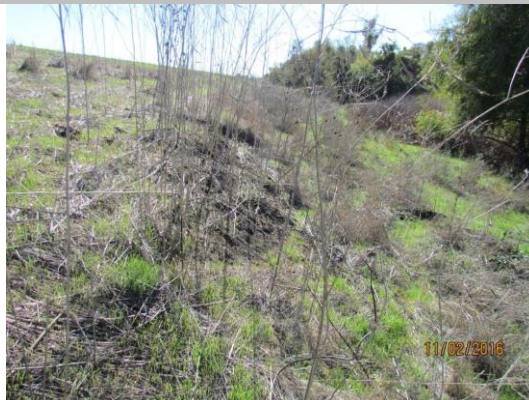
Photo 4 of 4 : SP\_2018\_RD1600\_192\_14\_20180306\_00010.jpg

Updated view of erosion site on WS slope. Fall 2016.

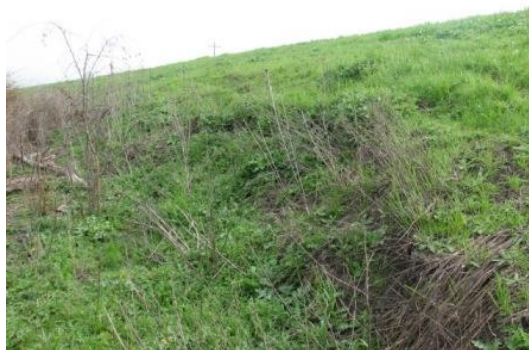
Photo 1 of 3 : SP\_2018\_RD1600\_192\_15\_20180306\_00011.jpg

Looking upstream a deeper cut of 2'-3' damage.

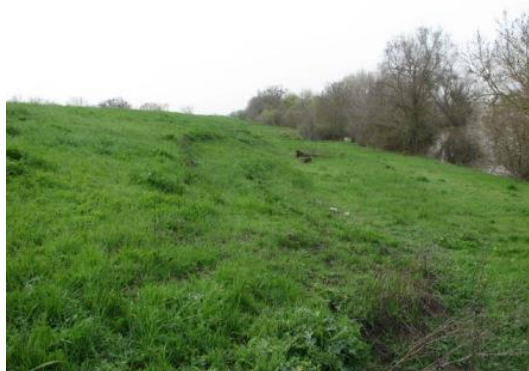
Photo 2 of 3 : SP\_2018\_RD1600\_192\_15\_20180306\_00012.jpg

This is wave wash damage along the toe of the levee looking downstream.

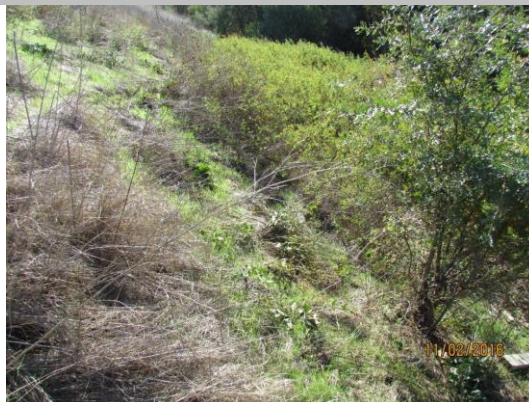
Photo 3 of 3 : SP\_2018\_RD1600\_192\_15\_20180306\_00013.jpg

Updated view of wave wash damage on WS slope. Fall 2016.

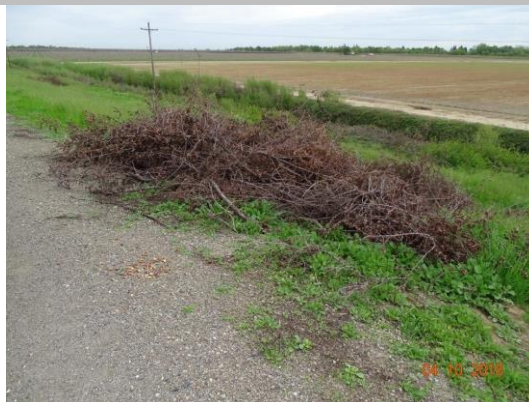
Photo 1 of 1 : SP\_2018\_RD1600\_192\_10\_20180413\_00026.jpg

View of pruning pile on the landside slope. Spring 2018.

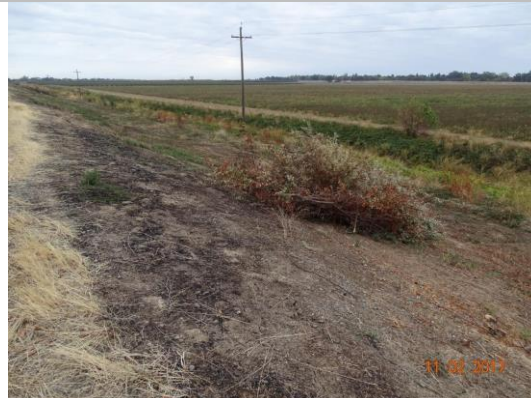
Photo 1 of 1 : SP\_2018\_RD1600\_192\_25\_20180306\_00020.jpg

View of pruning pile on landside slope. Fall 2017.

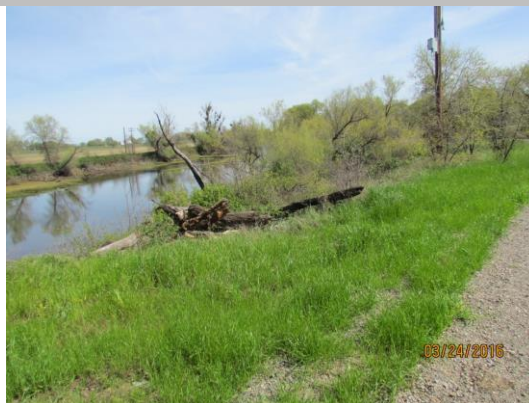
Photo 1 of 2 : SP\_2018\_RD1600\_192\_6\_20180306\_00003.jpg

View of the trees on the landward side of the levee looking downstream.  
Spring 2016.

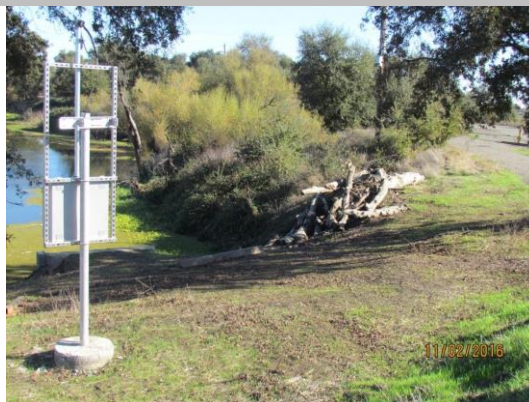
Photo 2 of 2 : SP\_2018\_RD1600\_192\_6\_20180306\_00004.jpg

View of debris on LS slope. Fall 2016.
